FROM: Eric Lindman, P.E.
Director of Public Works & Utilities

SUBJECT: 1300 Cleveland Ave – Environmental Document Review Summary

IN-FIELD CONDITIONS
CONNOR FOREST INDUSTRIES, INC.
WAUSAU CABINET PLANT
MARCH 4, 1986

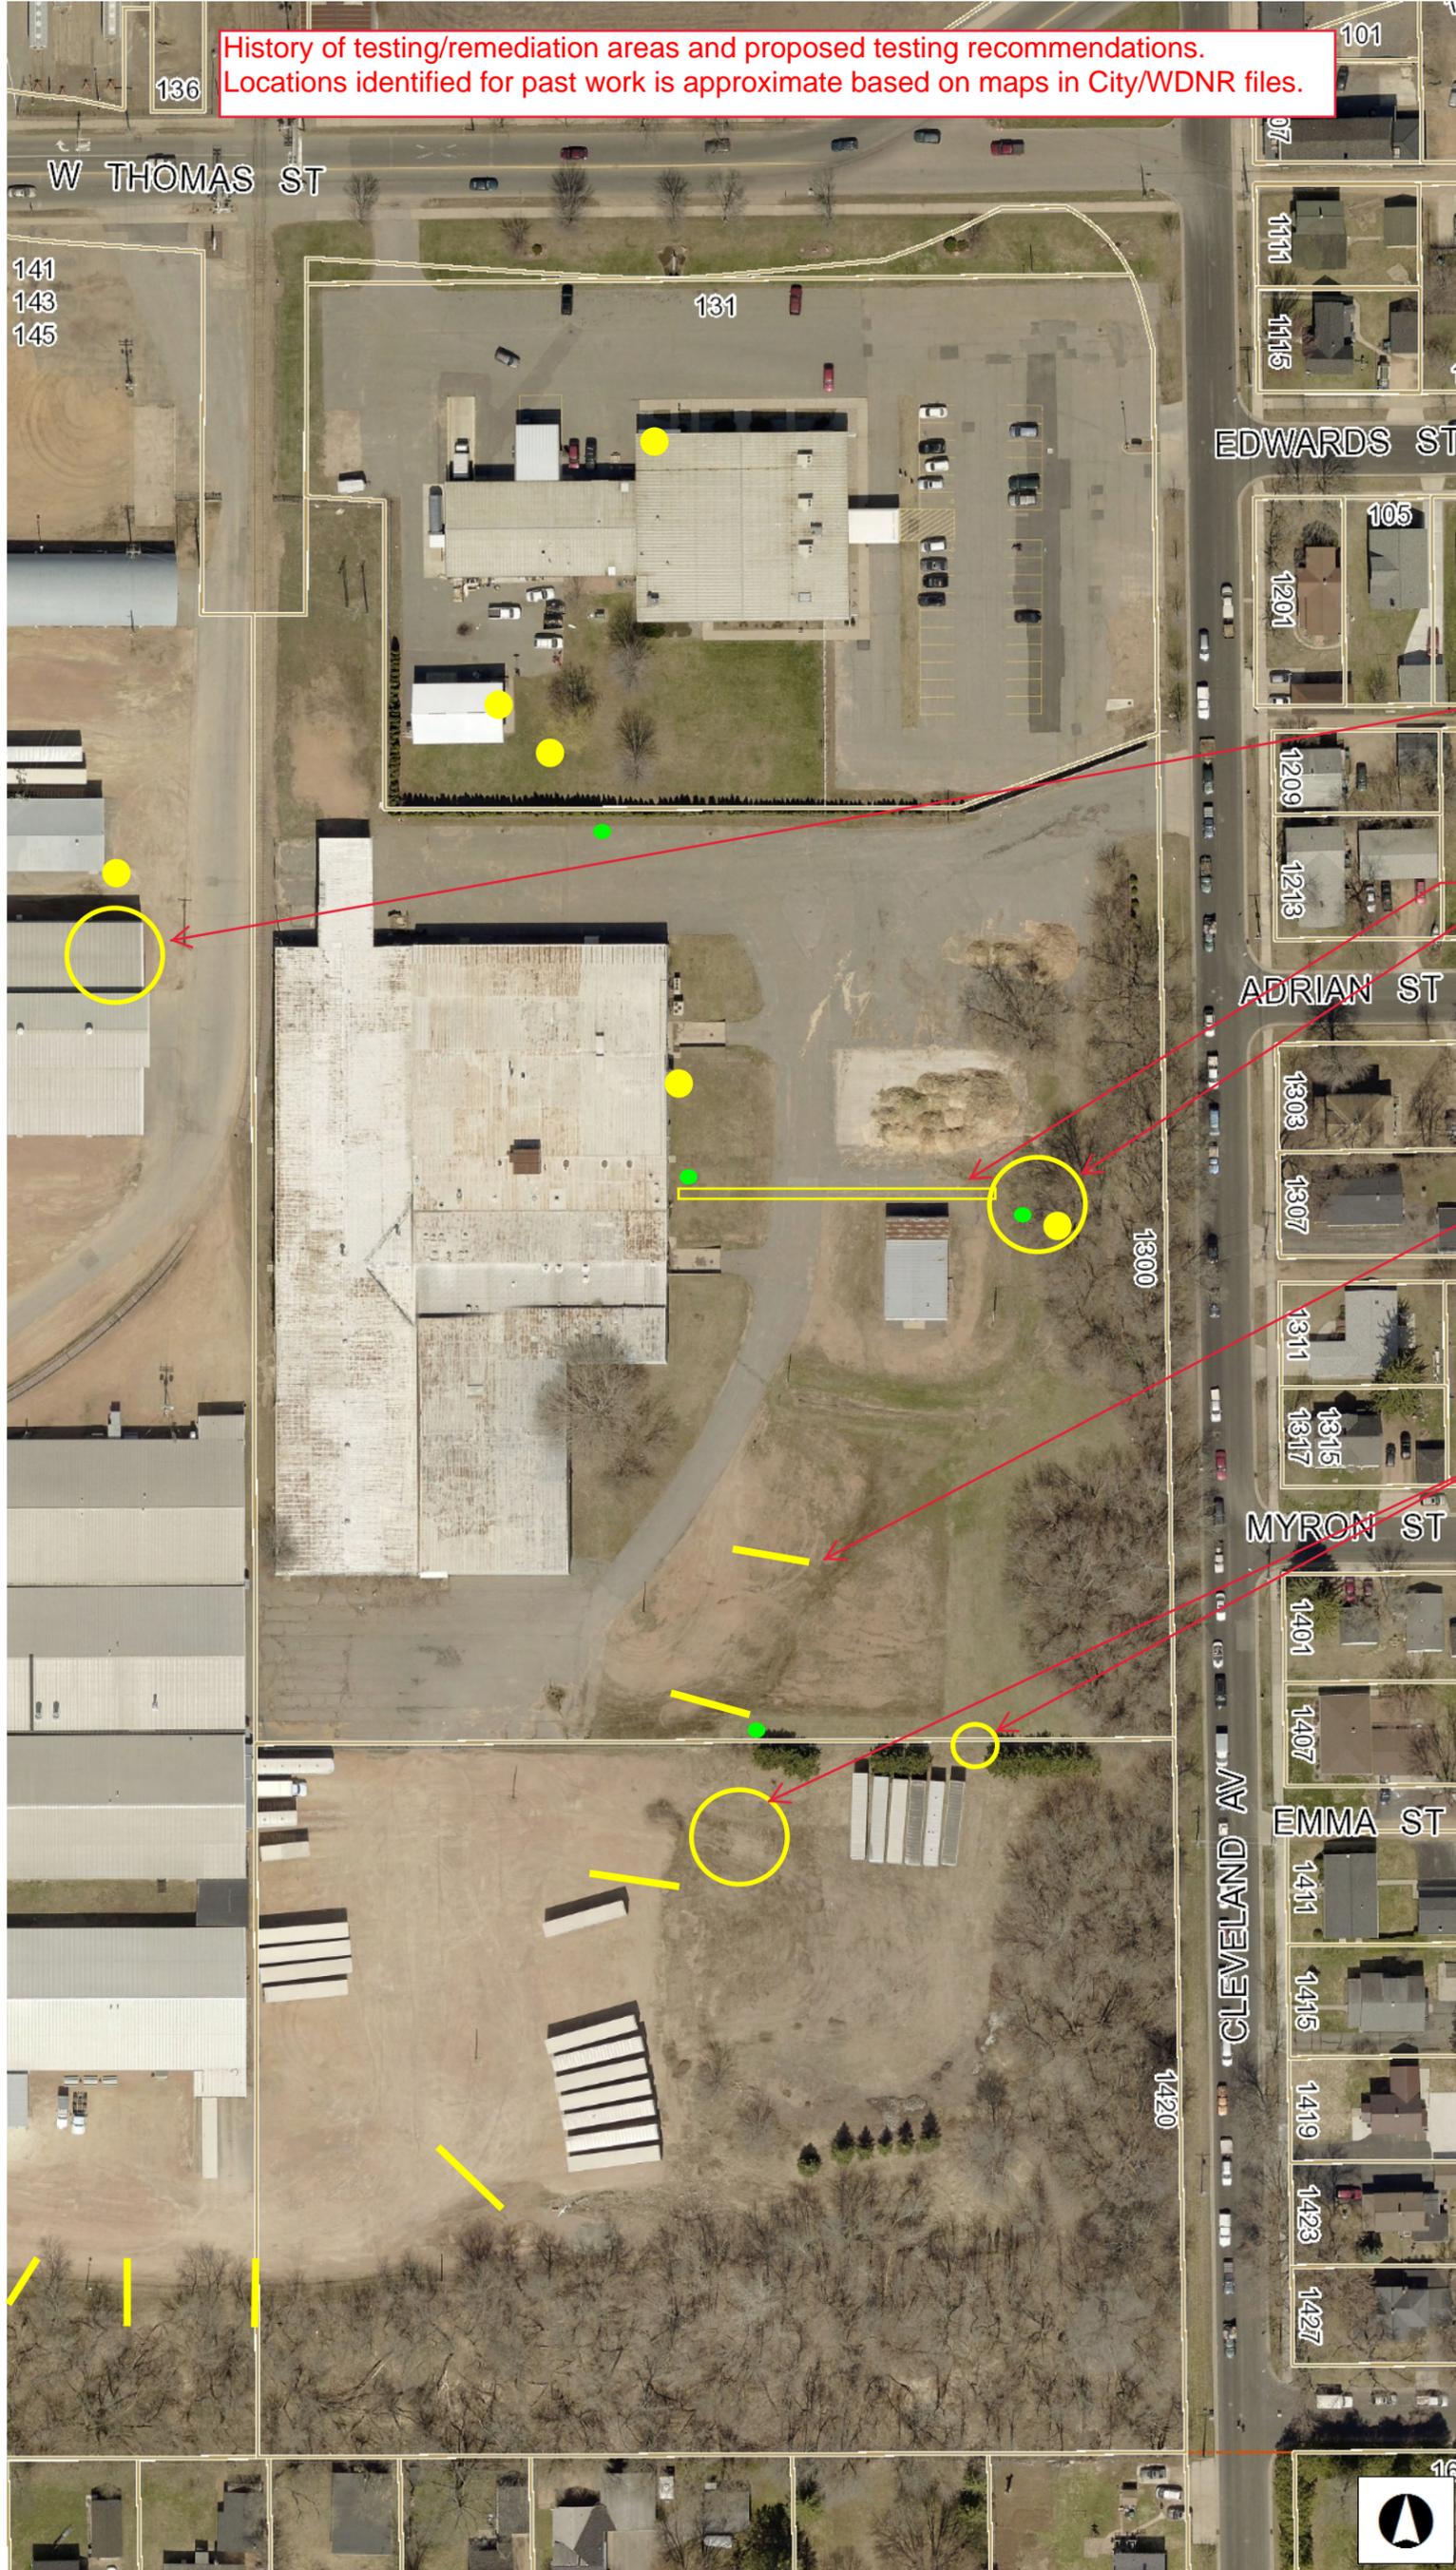
History of testing/remediation areas and proposed testing recommendations.
Locations identified for past work is approximate based on maps in City/WDNR files.

Buried Tanks Removed 1985

Area of underground piping; removed 1986

Based on the data and history of the site I would recommend moving ahead with Option 2, map attached. The site over the years was confirmed to have had heavy metals dumped onsite and the operations and data records were not well kept. The WDNR was heavily involved with remediation of areas on this site and there were full infield assessments completed of the site after CFI shut down the operation. There is a question on the testing that took place in the past; my primary reason for testing would be to focus on the testing of the native soils below any fill material. I feel it would be good due diligence for the City conduct a small number of borings in the areas identified in the past as having detects. You will see on the map that we no longer own some of the property and we would just be testing City owned property. The soil testing conducted by the City in 1986 indicated there may be a presence of heavy metals and this should be verified. Samples would be taken within the native soils as WDNR indicated these contaminants are more likely to be present and settled in the native soils versus remaining in the fill material.

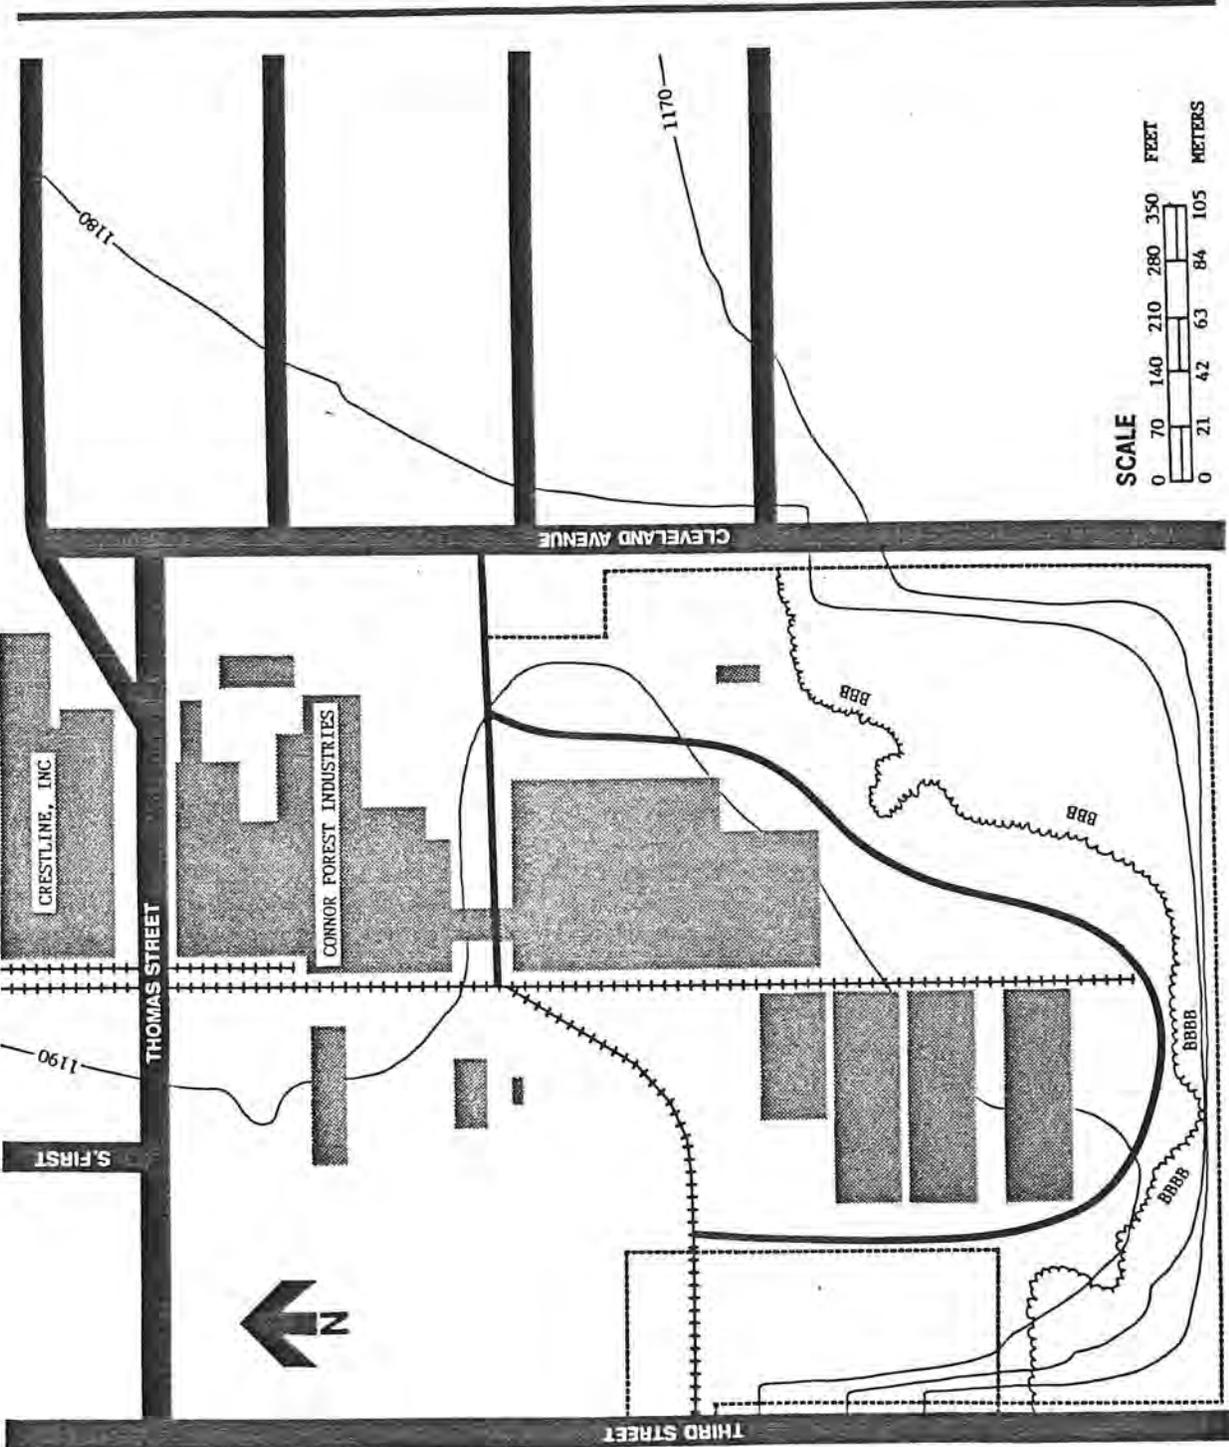
The southern 1/3 of the plant site is generally underlain by a thick fill layer of fine-grained rock flour, that appears to have originated from a nearby Minnesota Mining and Minerals (3M) facility that produces dyed, coarse grained, sand for roofing materials. The deposition of this fill material has resulted in a fairly steep slope along the far eastern and southern exposures of the property. Much of this sloped area (as shown on Figure 2) is thickly forested by opportunistic types of vegetation. It is in this sloped area that the exposed drums and construction debris had been found (Figure 2).

During inspection of the CFI site numerous drums and construction debris were noted along the toe of a slope along the southern fence line of the site (Figure 2). The drums were rusted, crushed, and partially buried. The condition of the drums, and the age of the trees growing among them, indicated that the drums had been in place for an estimated 15-25 years. Many of the drums appeared to have been covered at one time, and have subsequently been exposed by erosion along the toe of the slope and along drainages perpendicular to the slope. The drums have not been inventoried, but it was estimated that 50-75 of them were distributed along the site boundary. Many of the drums were inspected to see if they contain solids, liquids, or if they were empty. A few drums contained some liquid, however, based on their condition it is probable that the liquid was rain water. Other drums contained solids; either soil or in some cases glue resins were identified.

Based upon available on-site investigations, Geraghty & Miller recommends that the in-field assessment of the Connor Forest Industries Wausau Plant Site be terminated. However, it is recommended that the exposed drums at the CFI Wausau Plant Site be removed for both safety and aesthetic concerns.

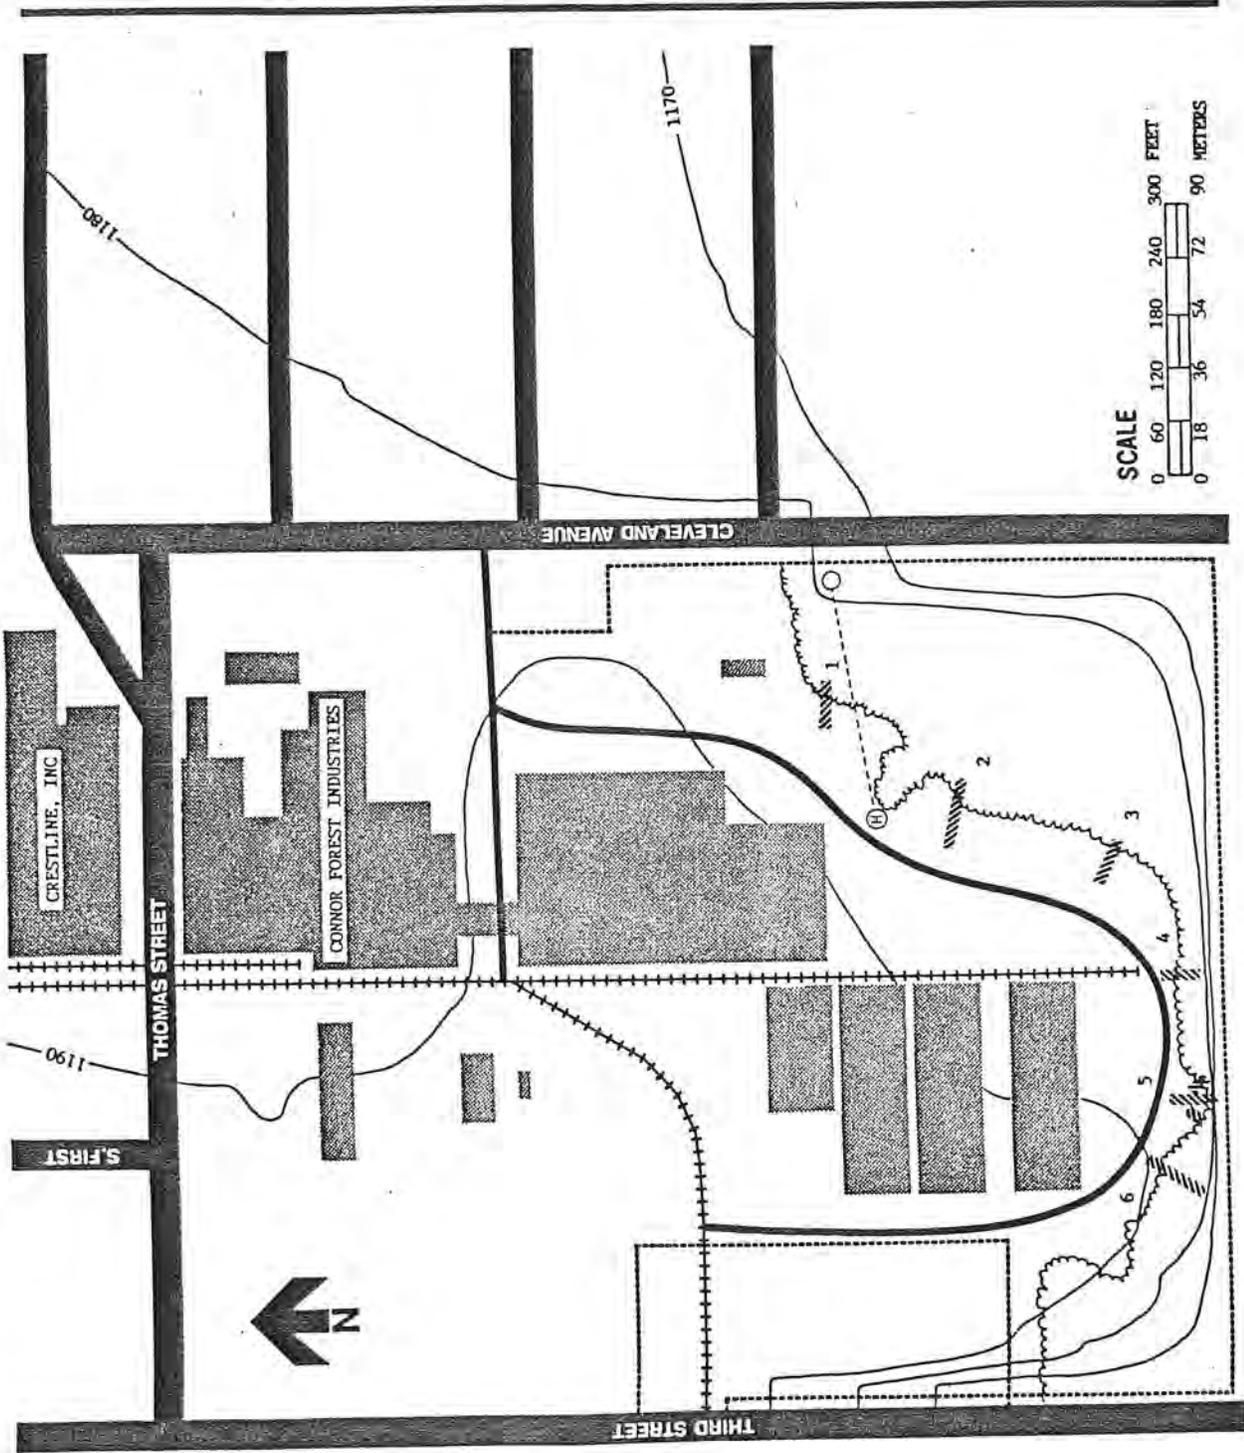
In summary, no buried barrels were found. Concrete, demolition material, crushed barrels and metal observed along the bank were only superficial material. Trenching indicated 3M tailings (rock flour) to be the ubiquitous and pervasive backfill component. In trenches one and six, some wood and sawdust were uncovered at the bottom. A brief description of each trench is as follows. A more detailed description should be provided in the contractor's report.

Uncovered four soil profiles. Mostly sand-gravel backfill, a 1-foot zone near the base of the trench had rotten logs and burlap sacks. No metal was found.

Rusted barrels on surface, some metal strapping on first 1-foot layer of soil at tree line; remainder is 3M backfill. Only one soil profile present.

This was dug across the reported 1981 fill area. About 50 feet out from tree line is a 30-foot long, 3-foot thick sawdust layer; remainder is 3M backfill. No metal waste was found. Only one soil profile present.
