FROM: Eric Lindman, P.E.
Director of Public Works & Utilities

SUBJECT: 1300 Cleveland Ave – Environmental Document Review Summary

IN-FIELD CONDITIONS
CONNOR FOREST INDUSTRIES, INC.
WAUSAU CABINET PLANT
MARCH 4, 1986

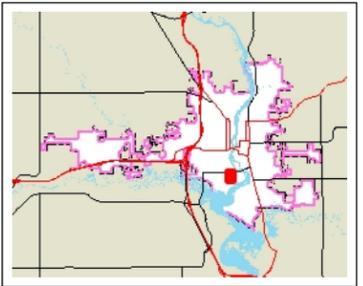
History of testing/remediation areas and proposed testing recommendations.
Locations identified for past work is approximate based on maps in City/WDNR files.

Based on the data and history of the site I would recommend moving ahead with Option 2, map attached. The site over the years was confirmed to have had heavy metals dumped onsite and the operations and data records were not well kept. The WDNR was heavily involved with remediation of areas on this site and there were full infield assessments completed of the site after CFI shut down the operation. There is a question on the testing that took place in the past; my primary reason for testing would be to focus on the testing of the native soils below any fill material. I feel it would be good due diligence for the City conduct a small number of borings in the areas identified in the past as having detects. You will see on the map that we no longer own some of the property and we would just be testing City owned property. The soil testing conducted by the City in 1986 indicated there may be a presence of heavy metals and this should be verified. Samples would be taken within the native soils as WDNR indicated these contaminants are more likely to be present and settled in the native soils versus remaining in the fill material.

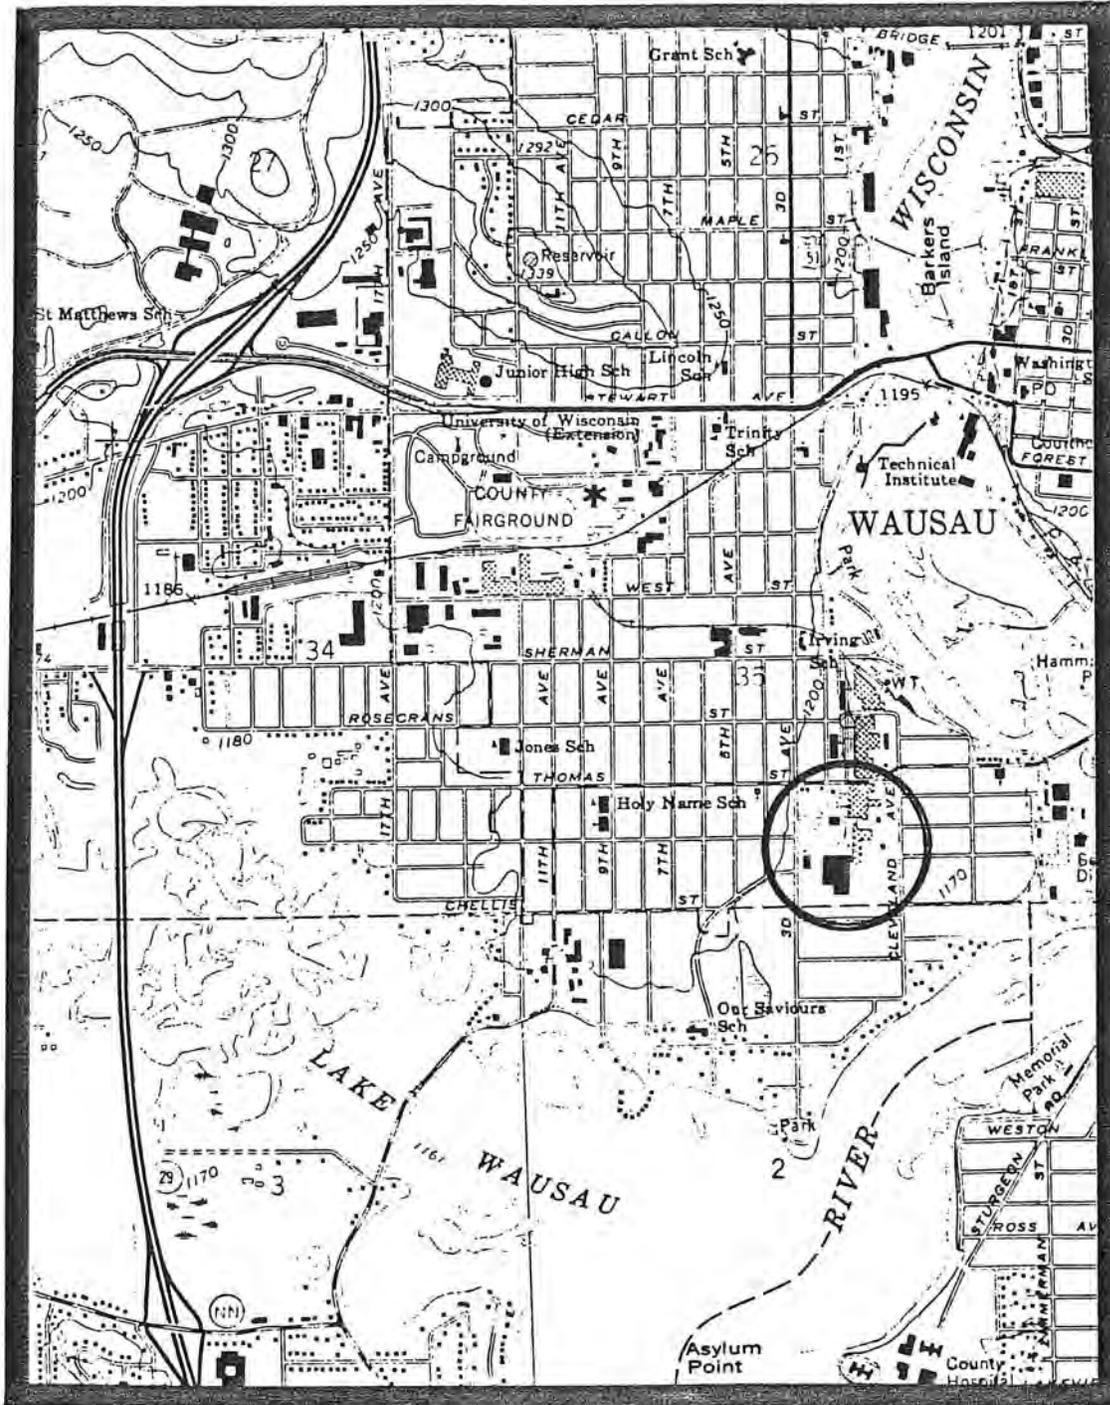
FIGURE 1: LOCATION OF CONNOR FOREST INDUSTRIES, INC.
WAUSAU PLANT, WAUSAU, WISCONSIN

The CFI Wausau Cabinet Plant is located west of the Wisconsin River in Wausau, Wisconsin (Figure 1). The site is approximately 22 acres in size, and is located at the southwest corner of Thomas Street and Cleveland Avenue. The site is located on what may have been an old flood plain of the Wisconsin River, approximately 40-60 feet above the current flood plain. To the north of the plant is another wood manufacturing plant operated by the Crestline Company.

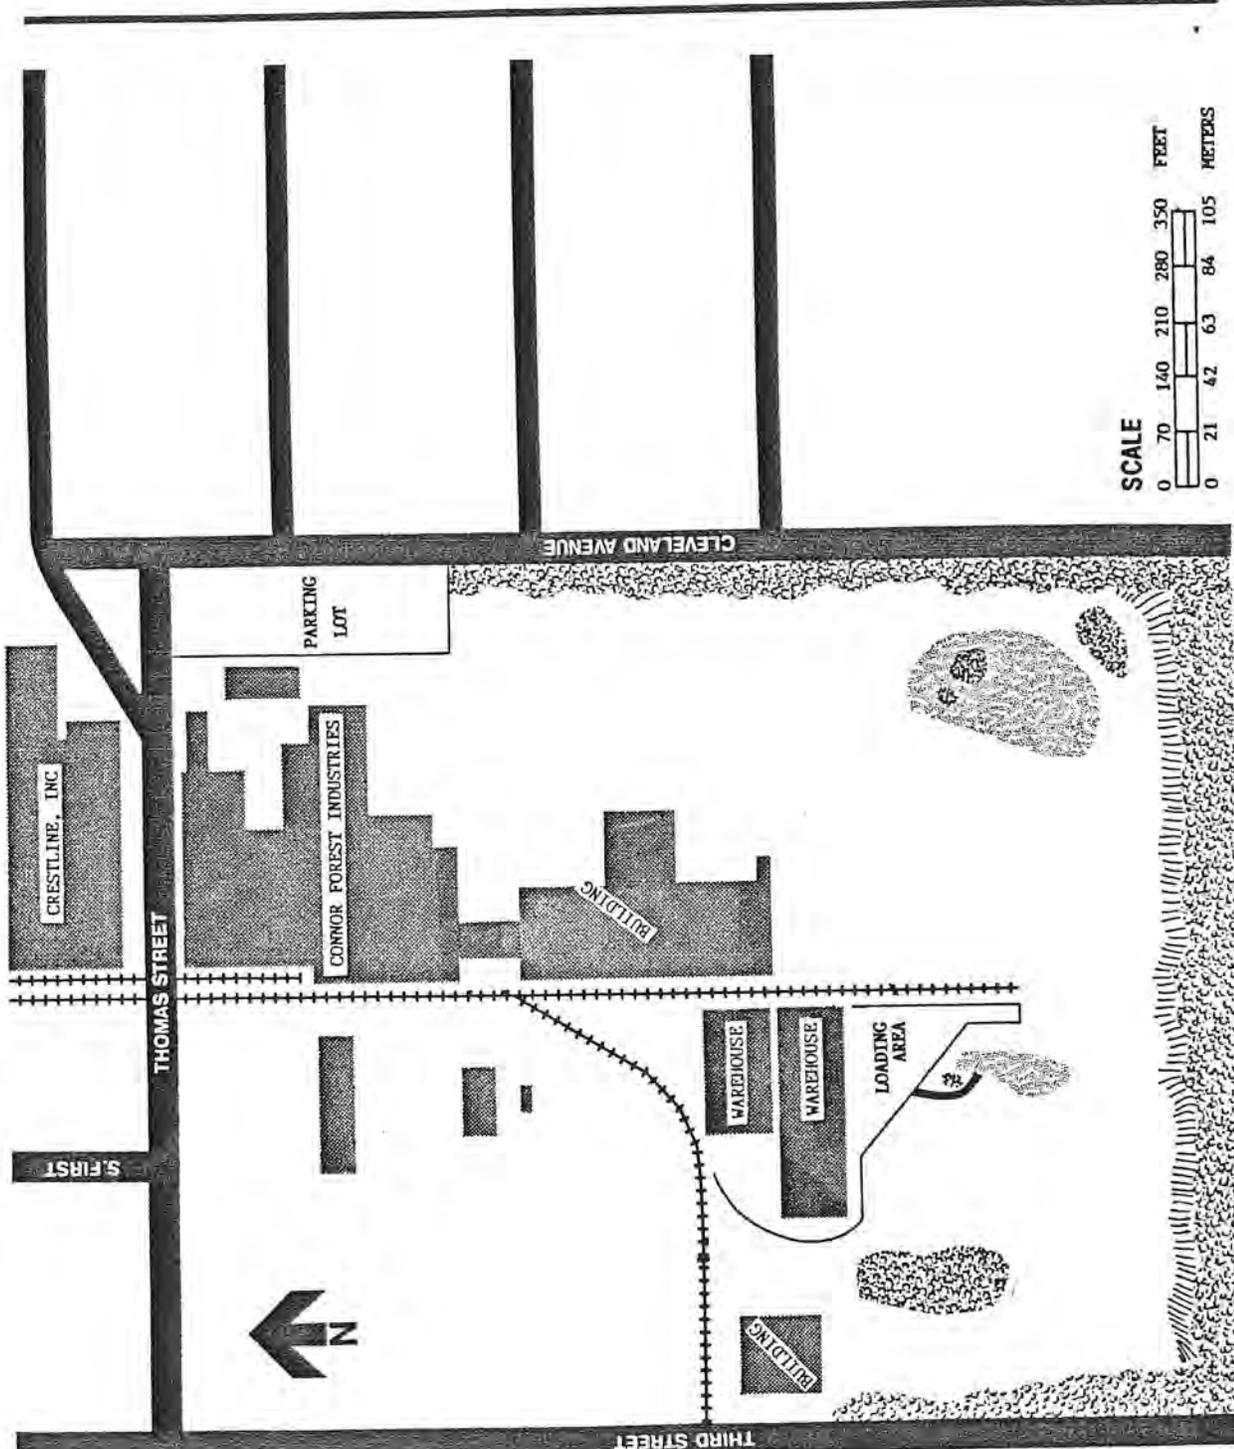
FIGURE 5.

1978 - The site is essentially the same as current conditions. The building south of the main plant has been expanded, the small storage area previously identified (cleared area) has been replaced by two large warehouses, the area is now fully wooded south of the on-site buildings. The heavy vegetation covers all aspects of the slope as well as a significant portion of the flat areas of the site (southeast and southwest corners of the property).
